Manhole Inspection Summary

Manhole # S43C2_020MH

Insp Date: **12/17/07 8:36 AM**

Location Address: **1119 Inner Cir**

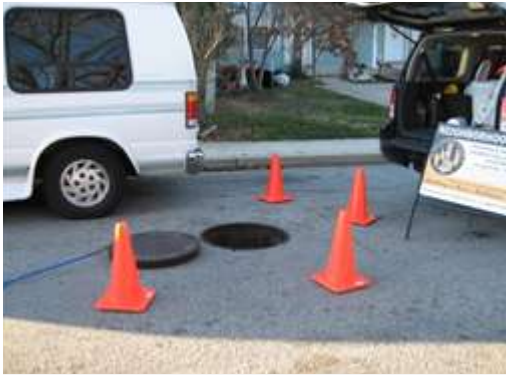
Location View

Inner Circle

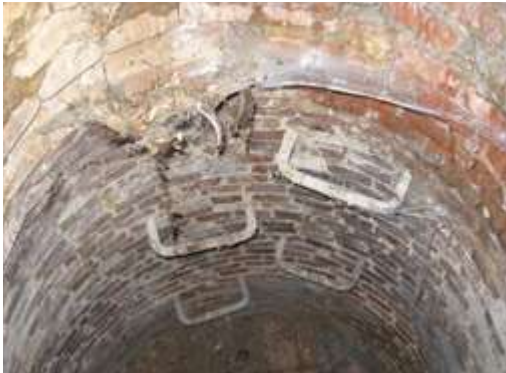
Steps

Count: **5** Missing: **0** ☐ Corroded

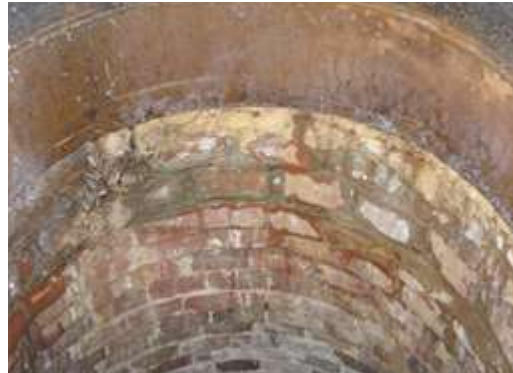
Defect 1

Infiltration: ☐ None ☐ Joint ☐ Cracks ☒ **Mortar** ☐ Roots ☐ Wall

Mortar

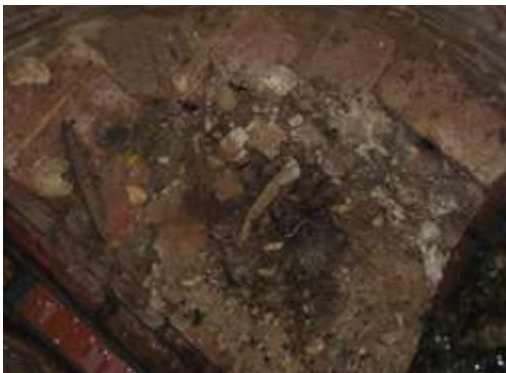
Defect 2

Debris

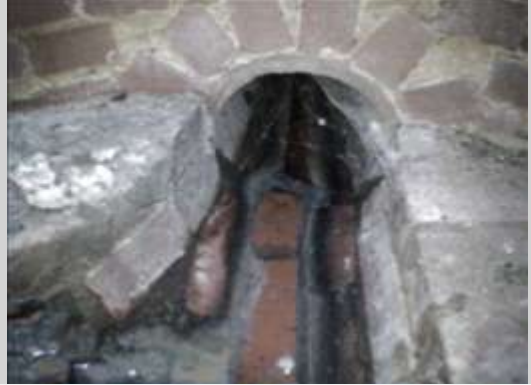
12 O'Clock Outflow

8 in. Circular Gravity Sewer
Pipe Out @ 12 O'Clock

Infiltration: **None** Pipe Seal Cond: **Sound**

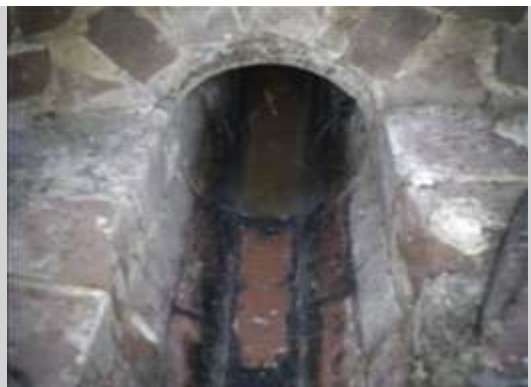
6 O'Clock Inflow

6 in. Circular Service Sewer
Pipe In @ 6 O'Clock

Infiltration: **None** Pipe Seal Cond: **Sound**

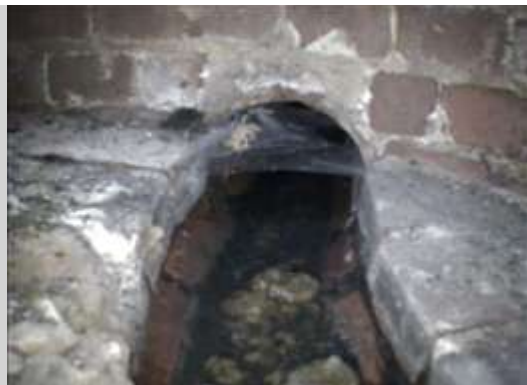
9 O'Clock Inflow

6 in. Circular Service Sewer
Pipe In @ 9 O'Clock

Infiltration: **None**

Pipe Seal Cond: **Sound**
